# BARBOUR MILL DAM

## PHASE I INSPECTION REPORT NATIONAL DAM SAFETY PROGRAM

NJ 00237

Name of Dam - Barbour Mill Dam, Passaic County, New Jersey  
Stream - Unnamed Tributary of Preakness Brook  
Dates of Inspection - 10 and 13 June 1978

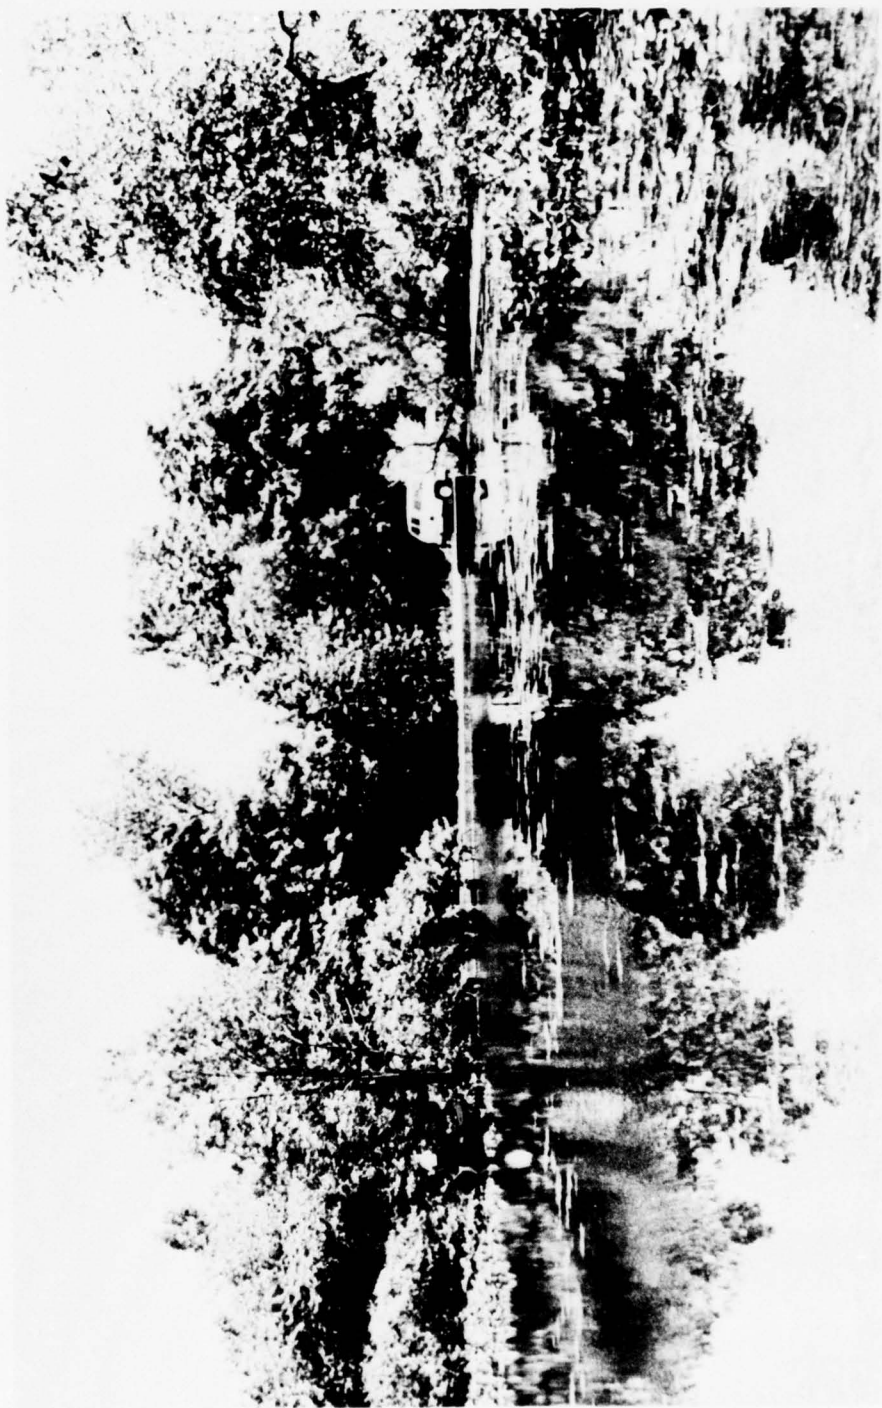
OVERALL VIEW OF DAM

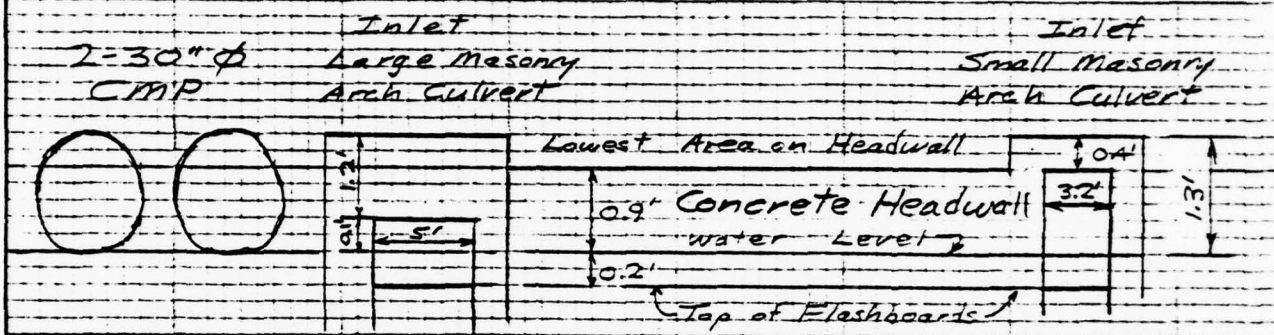
### UPSTREAM ELEVATION

Low Point on Embankment = 0.9' Free board as at Headwall - is approx 35' left of 30"  $\phi$  CMP.

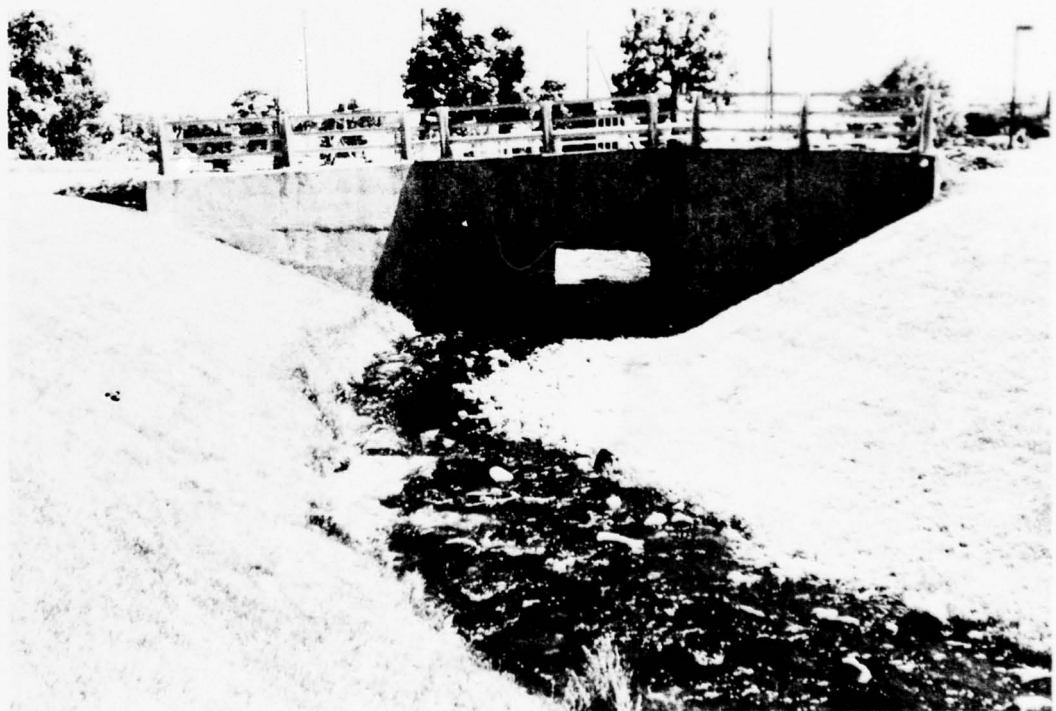
PHOTO 12

- Photo 12 - View South Along Downstream Channel Showing Bridge to Suburban Savings and Loan Parking Area. Bridge, Which Spans Box Culvert Twelve Feet Wide by Five Feet High; Is Located Approximately 400 Feet Downstream From Dam - 10 June 1978.
